## RELATIVE SEA LEVEL RISE EFFECTS AT THE MARAMBAIA BARRIER ISLAND AND GUARATIBA MANGROVE: SEPETIBA BAY (SE BRAZIL)

Costa Santos, C.S., Dias, F.F., Franz, B., Santos, P.R., Rodrigues, T., Vargas, R., Américo dos Santos, C., 2019. Relative Sea Level Rise Effects at the Marambaia Barrier Island and Guaratiba Mangrove: Sepetiba Bay (SE Brazil). *Journal of Sedimentary Environments*, 4 (3): 249-262.

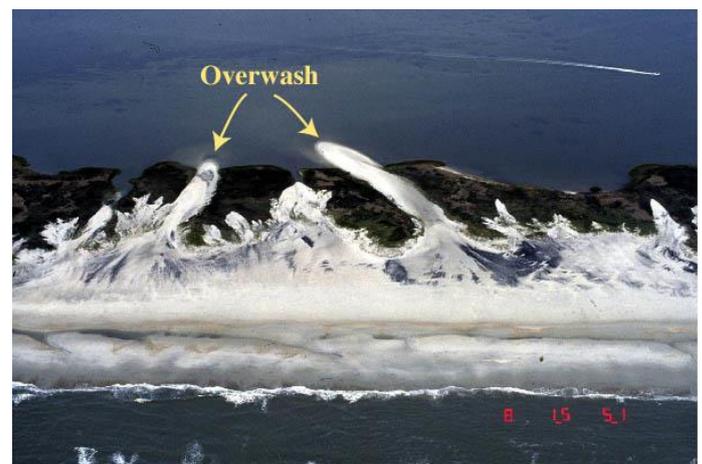
**Fig. 4.** Example of overwash. From: <http://coastal.er.usgs.gov/hurricanes/impact-scale/overwash.php>

One indicator of shoreline erosion is the overwash (Fig.4). Overwash is a natural storm-related process that occurs when wave run up over comes the dune crest (Rodrigues et al., 2012). Brantley et al. (2014) studied specific overwash sites and classified overwash features as “active overwash” if they lacked relief and exhibited evidences of recent overwash in the past 1–2 years. Recently disturbed sites that showed some dune accretions in the most recent overwash event were classified as “intermediate overwash”. Sites exhibiting evidence of overwash in the past several decades, but which were protected from wave action by seaward dunes at the time of the field survey were classified as “relict overwash”.

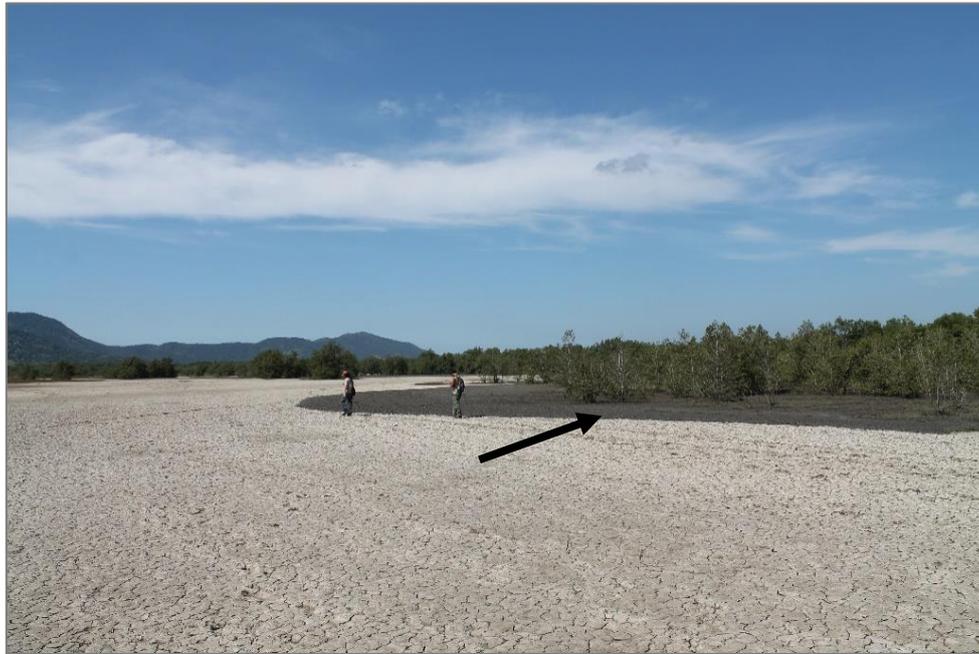
**Fig. 11.** Saltmarsh in Guaratiba. Indicating the gradual advance of mangrove in the saltmarshes (Date: 04/06/2016).

The sea level rise is influencing the zonation pattern in Guaratiba mangrove and the gradual advance of mangrove in the saltmarshes. In Guaratiba mangrove there are indications of erosion processes in the margin of the mangrove exposed to the bay and a growth of the mangrove for eastwards the saltmarshes and areas with dead trees as it was possible to observe in Figures 11, 12 and 13 where the saltmarsh is being colonized by mangrove trees (Guimarães,

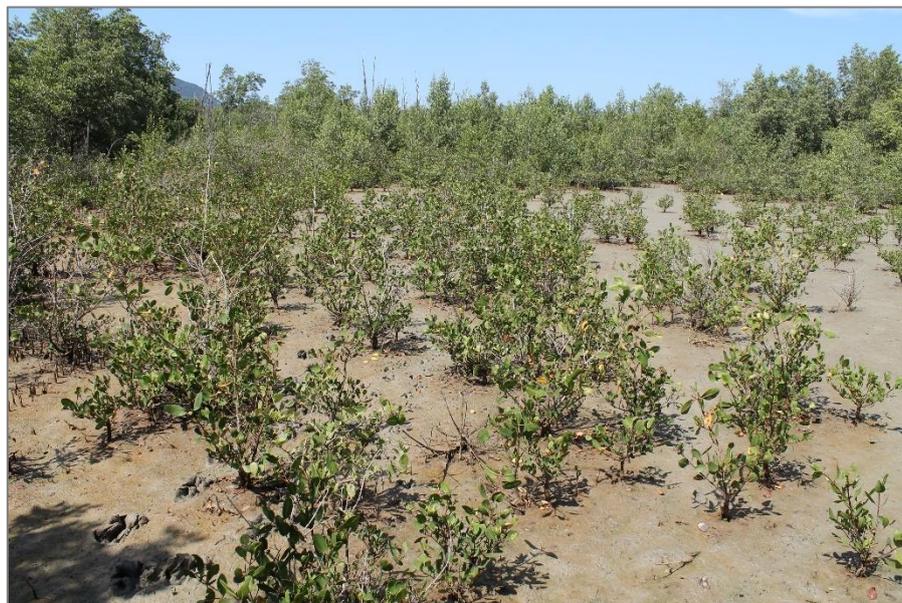
**Fig. 12.** Mangrove colonization in saltmarsh in the migration direction (Date: 04/06/2016)

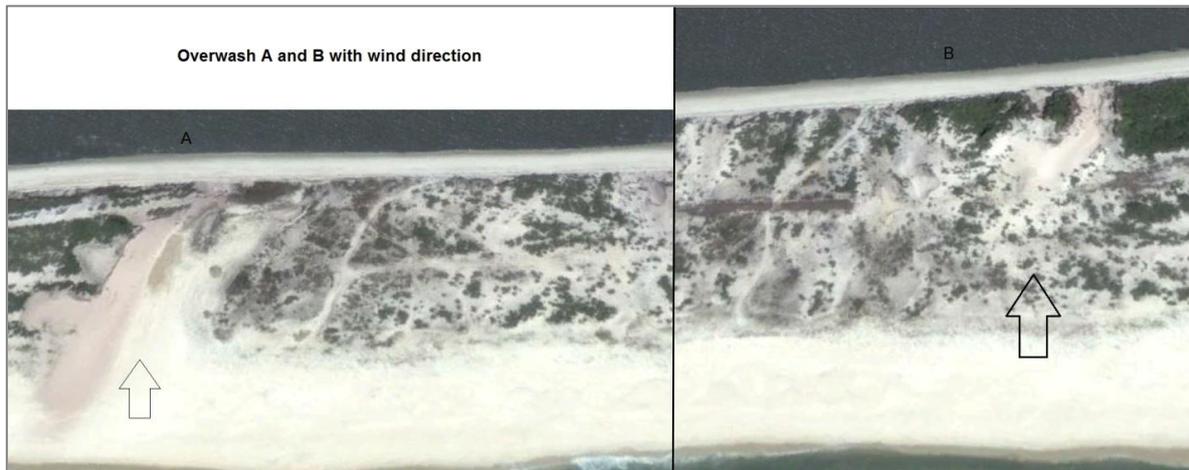
Fig. 15. Overwash in Marambaia barrier island.

The results for dunes and overwash for the Marambaia sand barrier were divided in five sectors (Fig.14): A, B and C for overwash events (Fig. 15), D for parabolic dunes (Fig. 16) and E and F for barchans dunes (Fig. 17)

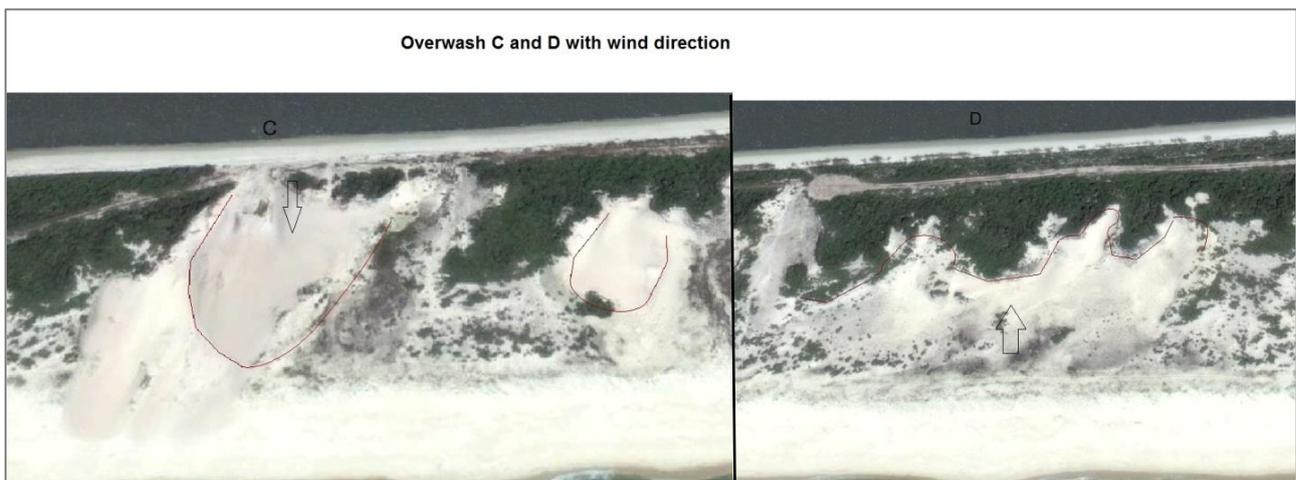
Fig. 16. Parabolic dunes in Marambaia Barrier Island.
